# ALERT

Learning from NCAR (L-QA-NCAR-01-60)

Poor ducting workmanship at PLS03 by WTY Engineering Sdn. Bhd. (as per attached photo).

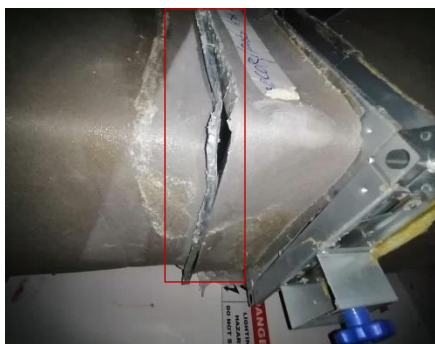
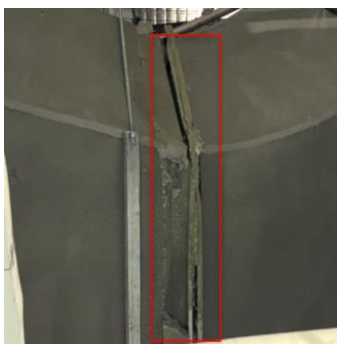
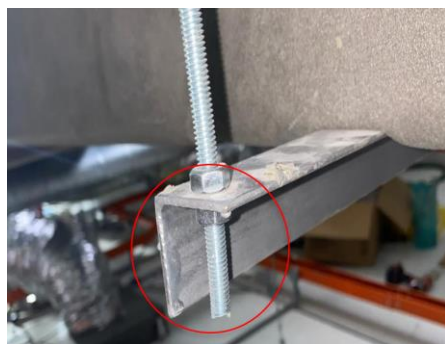
1. WTY failed to install ducting as per MOS even though training & refresher training has been conducted.
2. PLS03 Project Team constantly instruct and advise WTY on the correct way to install ducting works but they keep repeating the same mistakes.
3. Several Quality Site Inspection Reports have captured findings on ducting installation procedures.
4. Ducting works at Insulin Facility had major leaks and leads to HVAC air balancing failures.
5. WTY always short-staffed and failed to increase manpower on-site and this cause delay to site progress.

1. The worker are not fully aware on the Install & Insulate Ducting System Guideline/ Ducting Installation MOS and quality to be met and achieved.
2. No supervisor by WTY Engineering Sdn. Bhd. to monitor the workers during construction.
3. Insufficient manpower to meet the deadline of planned work.

1. The damage/ modified ducting were dismantled and installed with new ducting.
2. Improper insulation is removed and more adhesive/ glue were applied which come with adding insulation.

1. During TBM every morning, all workers need to be briefed on the standard and quality of work which includes the standard procedures that the workers has to comply with.
2. To provide one supervisor for each team in order to monitor the work progress closely.
3. To add at least one team for each minor work and two or three teams for major work (each team to have a supervisor for monitoring).
